Backflow Prevention *LATEST WATER REGULATION AUK 3*

**brownall Labtap®**

## SOLUTIONS

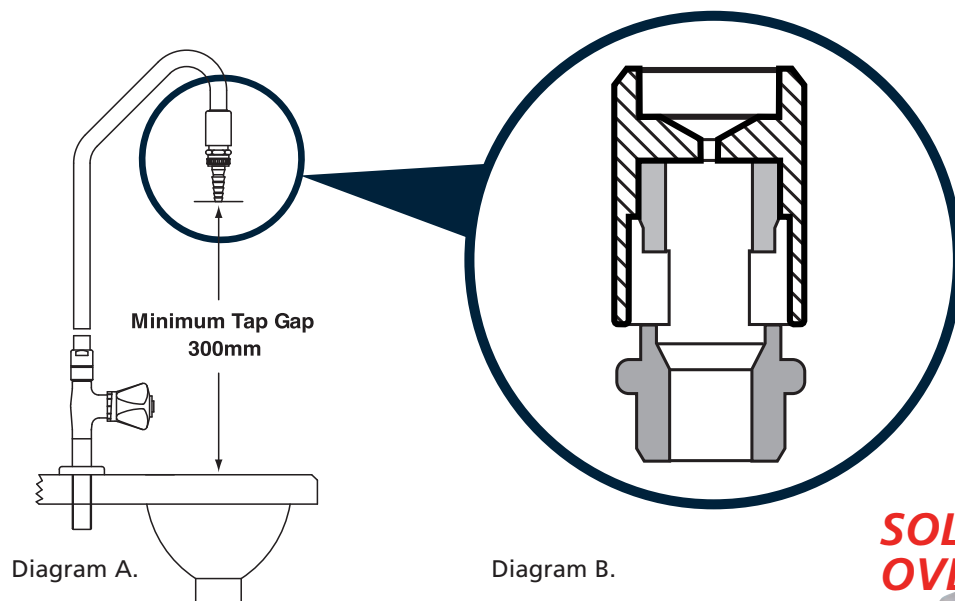
Diagram A.

3. A DC type pipe interrupter, (see diagram B.) with a permanent air gap must be fitted to each water outlet where a hose may be connected.
4. The distance between the outlet nozzle of the water tap and the spillover/bench level (called the Tap Gap) is a minimum of 300mm. See diagram A.

Diagram B.  
XL8082 DC with permanent air gap

The DC pipe interrupter Ref: XL8082 is also supplied separately and can be fitted to existing taps that are tall enough and have 1/2" BSP male thread on the nozzle or where an appropriate size adaptor may be used.
